Contract #: 04-0120F4Cty: SF/ALA Rte: 80 PM: 13.2/13.9File #: 69.28**WELDING INSPECTION REPORT****Resident Engineer:**Pursell, Gary**Address:** 333 Burma Road**City:** Oakland, CA 94607**Report No:** WIR-002819**Date Inspected:** 30-May-2008**Project Name:** SAS Superstructure**OSM Arrival Time:** 700**Prime Contractor:** American Bridge/Fluor Enterprises, a JV**OSM Departure Time:** 1700**Contractor:** Zhenhua Port Machinery Company, Ltd (ZPMC), Changxing Island **Location:** Shanghai, China**CWI Name:** Sun Wei**CWI Present:** Yes No**Inspected CWI report:** Yes No N/A**Rod Oven in Use:** Yes No N/A**Electrode to specification:** Yes No N/A**Weld Procedures Followed:** Yes No N/A**Qualified Welders:** Yes No N/A**Verified Joint Fit-up:** Yes No N/A**Approved Drawings:** Yes No N/A**Approved WPS:** Yes No N/A**Delayed / Cancelled:** Yes No N/A**Bridge No:** 34-0006**Component:** Tower and OBG**Summary of Items Observed:**

89M Strut Mock-up Macro Samples

WELDING INSPECTION REPORT

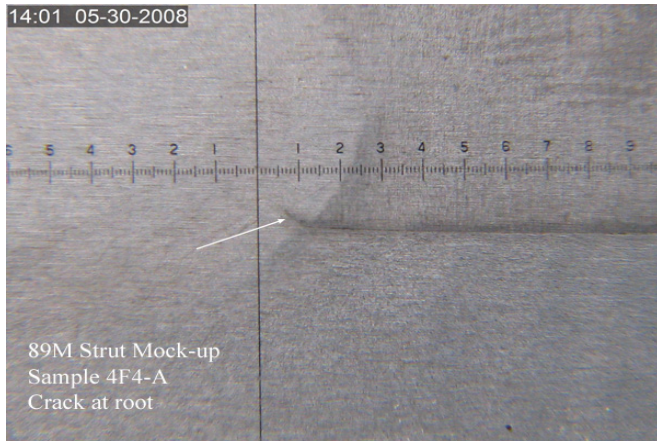
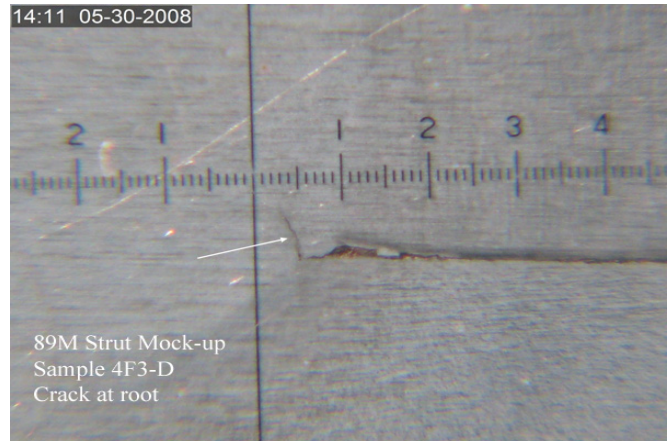
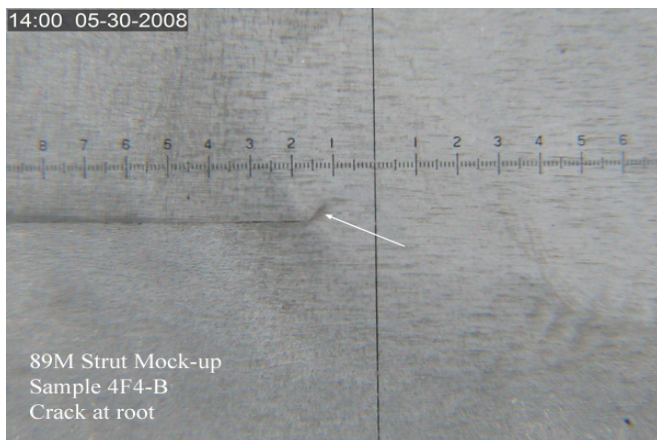
unacceptable. One sample was rejected for a linear indication and one for incomplete fusion. The Quality Assurance Inspector reviewed the samples and recorded four samples with cracks in the root and one sample with incomplete penetration. After some discussion, the Quality Assurance Inspector, Mr. Williams, and Xie Ping all agreed on the Quality Assurance Inspectors findings. The Quality Assurance Inspector recorded the results of the evaluation and photographed the samples. The data was forwarded to Assistant Structures Representative Josh Ishibashi for review. Below are three digital photographs illustrating three of the cracked fillet welds.
